# Uniform Mitigation Verification Inspection Form

Inspection Date: FEBRUARY 1, 2025		
<b>Owner Information</b>		
Owner Name: MIDDLEBROOK PINES CONDOS CASE#: 20250201-WMIR-01		Contact Person: KEITH KIEBZAK
Address: 5250, 5252, 5254, 5256 MIDDLE CT - BLDG 1		Home Phone:
City: ORLANDO	Zip: 32811	Work Phone: 407-482-2622
County: ORANGE	FL	Cell Phone:
Insurance Company:		Policy #:
Year of Home: 1984	# of Stories: 2	Email: KLMGMTGROUP@AOL.COM

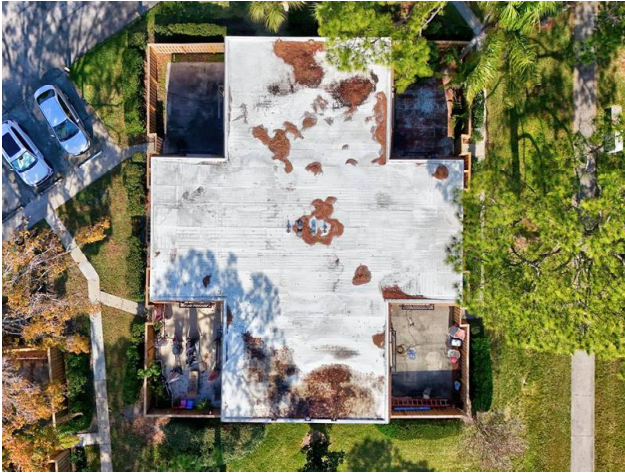
2.1 Roof Covering Type:	Permit Application Date	FBC or MDC Product Approval #	Year of Original Installation or Replacement	No Information Provided for Compliance
<input type="checkbox"/> 1. Asphalt/Fiberglass Shingle	____/____/____	_____	_____	<input type="checkbox"/>
<input type="checkbox"/> 2. Concrete/Clay Tile	____/____/____	_____	_____	<input type="checkbox"/>
<input type="checkbox"/> 3. Metal	____/____/____	_____	_____	<input type="checkbox"/>
<input type="checkbox"/> 4. Built Up	____/____/____	_____	_____	<input type="checkbox"/>
<input type="checkbox"/> 5. Membrane	____/____/____	_____	_____	<input type="checkbox"/>
<input checked="" type="checkbox"/> 6. Other Concrete/TPO	6/16/2011	_____	_____	<input type="checkbox"/>

- ☒ D. Reinforced Concrete Roof Deck.  
☐ E. Other: \_\_\_\_\_  
☐ F. Unknown or unidentified.  
☐ G. No attic access.

- ☒ E. Structural      Anchor bolts structurally connected or reinforced concrete roof.  
☐ F. Other: \_\_\_\_\_  
☐ G. Unknown or unidentified  
☐ H. No attic access

ROOF - CONCRETE WITH TPO COVERING
