Uniform Mitigation Verification Inspection Form

Inspection Date: FEBRUARY 1, 2025		
Owner Information		
Owner Name: MIDDLEBROOK PINES CONDOS CASE#: 20250201-WMIR-19		Contact Person: KEITH KIEBZAK
Address: 5267, 5269, 5271, 5273 BROOK CT - BLDG 19		Home Phone:
City: ORLANDO	Zip: 32811	Work Phone: 407-482-2622
County: ORANGE	FL	Cell Phone:
Insurance Company:		Policy #:
Year of Home: 1985	# of Stories: 2	Email: KLMGMTGROUP@AOL.COM

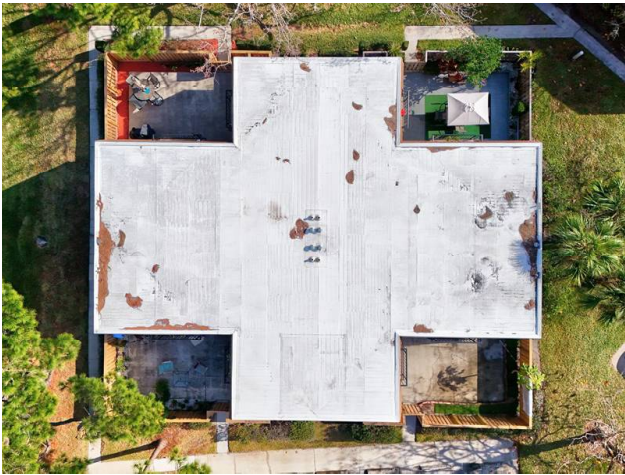
2.1 Roof Covering Type:	Permit Application Date	FBC or MDC Product Approval #	Year of Original Installation or Replacement	No Information Provided for Compliance
<input type="checkbox"/> 1. Asphalt/Fiberglass Shingle	____/____/____	_____	_____	<input type="checkbox"/>
<input type="checkbox"/> 2. Concrete/Clay Tile	____/____/____	_____	_____	<input type="checkbox"/>
<input type="checkbox"/> 3. Metal	____/____/____	_____	_____	<input type="checkbox"/>
<input type="checkbox"/> 4. Built Up	____/____/____	_____	_____	<input type="checkbox"/>
<input type="checkbox"/> 5. Membrane	____/____/____	_____	_____	<input type="checkbox"/>
<input checked="" type="checkbox"/> 6. Other Concrete/TPO	4/22/2011	_____	_____	<input type="checkbox"/>

- ☒ D. Reinforced Concrete Roof Deck.
☐ E. Other: _____
☐ F. Unknown or unidentified.
☐ G. No attic access.

- ☒ E. Structural Anchor bolts structurally connected or reinforced concrete roof.
☐ F. Other: _____
☐ G. Unknown or unidentified
☐ H. No attic access

ROOF - CONCRETE WITH TPO COVERING
