Uniform Mitigation Verification Inspection Form

Inspection Date: FEBRUARY 1, 2025		
Owner Information		
Owner Name: MIDDLEBROOK PINES CONDOS CASE#: 20250201-WMIR-35		Contact Person: KEITH KIEBZAK
Address: 5358, 5360, 5362, 5364 ELM CT - BLDG 35		Home Phone:
City: ORLANDO	Zip: 32811	Work Phone: 407-482-2622
County: ORANGE	FL	Cell Phone:
Insurance Company:		Policy #:
Year of Home: 1985	# of Stories: 2	Email: KLMGMTGROUP@AOL.COM

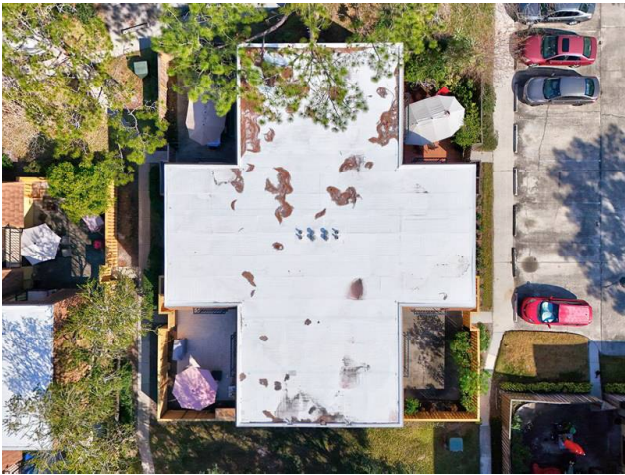
2.1 Roof Covering Type:	Permit Application Date	FBC or MDC Product Approval #	Year of Original Installation or Replacement	No Information Provided for Compliance
<input type="checkbox"/> 1. Asphalt/Fiberglass Shingle	____/____/____	_____	_____	<input type="checkbox"/>
<input type="checkbox"/> 2. Concrete/Clay Tile	____/____/____	_____	_____	<input type="checkbox"/>
<input type="checkbox"/> 3. Metal	____/____/____	_____	_____	<input type="checkbox"/>
<input type="checkbox"/> 4. Built Up	____/____/____	_____	_____	<input type="checkbox"/>
<input type="checkbox"/> 5. Membrane	____/____/____	_____	_____	<input type="checkbox"/>
<input checked="" type="checkbox"/> 6. Other Concrete/TPO	9/20/2010	_____	_____	<input type="checkbox"/>

- ☒ D. Reinforced Concrete Roof Deck.
☐ E. Other: _____
☐ F. Unknown or unidentified.
☐ G. No attic access.

- ☒ E. Structural Anchor bolts structurally connected or reinforced concrete roof.
☐ F. Other: _____
☐ G. Unknown or unidentified
☐ H. No attic access

ROOF - CONCRETE WITH TPO COVERING
