Uniform Mitigation Verification Inspection Form

Inspection Date: FEBRUARY 1, 2025		
Owner Information		
Owner Name: MIDDLEBROOK PINES CONDOS CASE#: 20250201-WMIR-39		Contact Person: KEITH KIEBZAK
Address: 5363, 5365, 5367, 5369 BAMBOO CT - BLDG 39		Home Phone:
City: ORLANDO	Zip: 32811	Work Phone: 407-482-2622
County: ORANGE	FL	Cell Phone:
Insurance Company:		Policy #:
Year of Home: 1986	# of Stories: 2	Email: KLMGMTGROUP@AOL.COM

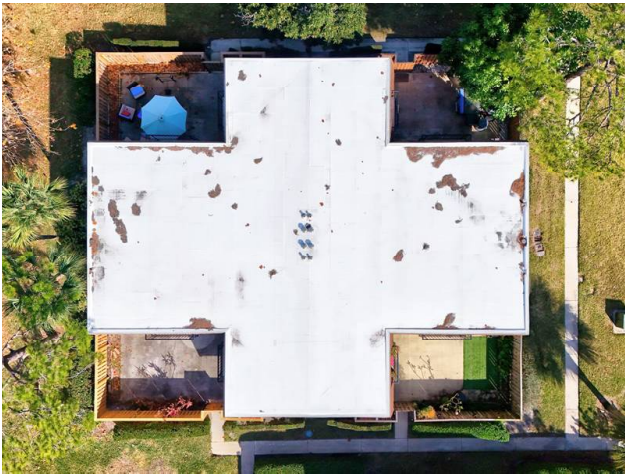
- ☒ D. Reinforced Concrete Roof Deck.
☐ E. Other: _____
☐ F. Unknown or unidentified.
☐ G. No attic access.

- ☒ E. Structural Anchor bolts structurally connected or reinforced concrete roof.
☐ F. Other: _____
☐ G. Unknown or unidentified
☐ H. No attic access

ROOF - CONCRETE WITH TPO COVERING
