Uniform Mitigation Verification Inspection Form

Inspection Date: FEBRUARY 1, 2025		
Owner Information		
Owner Name: MIDDLEBROOK PINES CONDOS CASE#: 20250201-WMIR-45		Contact Person: KEITH KIEBZAK
Address: 5323, 5325, 5327, 5329 BAMBOO CT - BLDG 45		Home Phone:
City: ORLANDO	Zip: 32811	Work Phone: 407-482-2622
County: ORANGE	FL	Cell Phone:
Insurance Company:		Policy #:
Year of Home: 1986	# of Stories: 2	Email: KLMGMTGROUP@AOL.COM

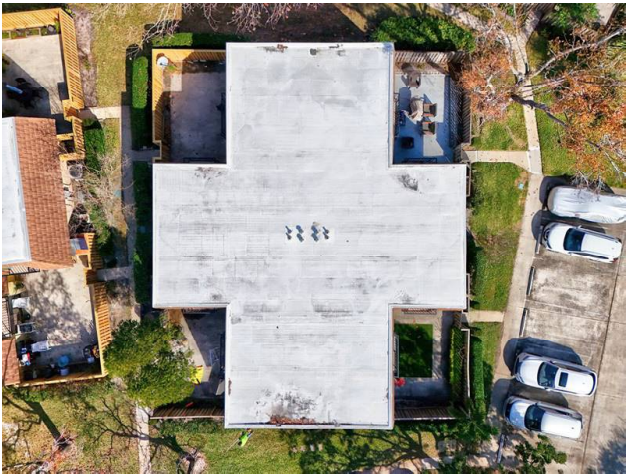
2.1 Roof Covering Type:	Permit Application Date	FBC or MDC Product Approval #	Year of Original Installation or Replacement	No Information Provided for Compliance
<input type="checkbox"/> 1. Asphalt/Fiberglass Shingle	____/____/____	_____	_____	<input type="checkbox"/>
<input type="checkbox"/> 2. Concrete/Clay Tile	____/____/____	_____	_____	<input type="checkbox"/>
<input type="checkbox"/> 3. Metal	____/____/____	_____	_____	<input type="checkbox"/>
<input type="checkbox"/> 4. Built Up	____/____/____	_____	_____	<input type="checkbox"/>
<input type="checkbox"/> 5. Membrane	____/____/____	_____	_____	<input type="checkbox"/>
<input checked="" type="checkbox"/> 6. Other Concrete/TPO	10/20/09	_____	_____	<input type="checkbox"/>

- ☒ D. Reinforced Concrete Roof Deck.
☐ E. Other: _____
☐ F. Unknown or unidentified.
☐ G. No attic access.

- ☒ E. Structural Anchor bolts structurally connected or reinforced concrete roof.
☐ F. Other: _____
☐ G. Unknown or unidentified
☐ H. No attic access

- ☐ A. Hip Roof Hip roof with no other roof shapes greater than 10% of the total roof system perimeter.
Total length of non-hip features: _____ feet; Total roof system perimeter: _____ feet
- ☒ B. Flat Roof Roof on a building with 5 or more units where at least 90% of the main roof area has a roof slope of less than 2:12. Roof area with slope less than 2:12 _____ sq ft; Total roof area _____ sq ft
- ☐ C. Other Roof Any roof that does not qualify as either (A) or (B) above.

ROOF - CONCRETE WITH TPO COVERING
