Uniform Mitigation Verification Inspection Form

Inspection Date: FEBRUARY 1, 2025		
Owner Information		
Owner Name: MIDDLEBROOK PINES CONDOS CASE#: 20250201-WMIR-47		Contact Person: KEITH KIEBZAK
Address: 5281, 5283, 5285, 5287 CYPRESS CT - BLDG 47		Home Phone:
City: ORLANDO	Zip: 32811	Work Phone: 407-482-2622
County: ORANGE	FL	Cell Phone:
Insurance Company:		Policy #:
Year of Home: 1986	# of Stories: 2	Email: KLMGMTGROUP@AOL.COM

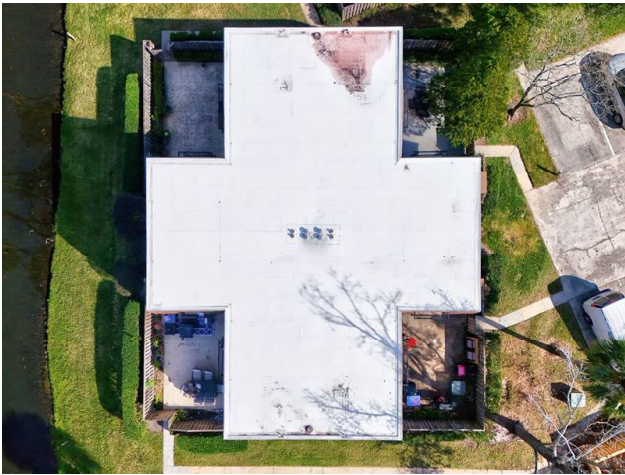
2.1 Roof Covering Type:	Permit Application Date	FBC or MDC Product Approval #	Year of Original Installation or Replacement	No Information Provided for Compliance
<input type="checkbox"/> 1. Asphalt/Fiberglass Shingle	____/____/____	_____	_____	<input type="checkbox"/>
<input type="checkbox"/> 2. Concrete/Clay Tile	____/____/____	_____	_____	<input type="checkbox"/>
<input type="checkbox"/> 3. Metal	____/____/____	_____	_____	<input type="checkbox"/>
<input type="checkbox"/> 4. Built Up	____/____/____	_____	_____	<input type="checkbox"/>
<input type="checkbox"/> 5. Membrane	____/____/____	_____	_____	<input type="checkbox"/>
<input checked="" type="checkbox"/> 6. Other Concrete/TPO	8/30/2010	_____	_____	<input type="checkbox"/>

- ☒ D. Reinforced Concrete Roof Deck.
☐ E. Other: _____
☐ F. Unknown or unidentified.
☐ G. No attic access.

- ☒ E. Structural Anchor bolts structurally connected or reinforced concrete roof.
☐ F. Other: _____
☐ G. Unknown or unidentified
☐ H. No attic access

ROOF - CONCRETE WITH TPO COVERING
