Uniform Mitigation Verification Inspection Form

Inspection Date: FEBRUARY 1, 2025		
Owner Information		
Owner Name: MIDDLEBROOK PINES CONDOS CASE#: 20250201-WMIR-59		Contact Person: KEITH KIEBZAK
Address: 5348, 5350, 5352, 5354 BAMBOO CT - BLDG 59		Home Phone:
City: ORLANDO	Zip: 32811	Work Phone: 407-482-2622
County: ORANGE	FL	Cell Phone:
Insurance Company:		Policy #:
Year of Home: 1986	# of Stories: 2	Email: KLMGMTGROUP@AOL.COM

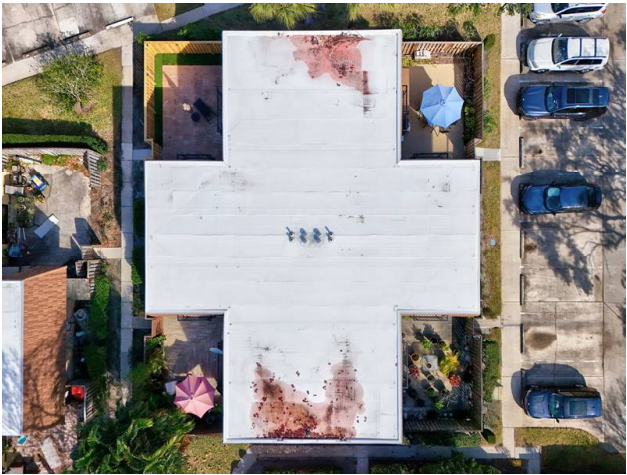
2.1 Roof Covering Type:	Permit Application Date	FBC or MDC Product Approval #	Year of Original Installation or Replacement	No Information Provided for Compliance
<input type="checkbox"/> 1. Asphalt/Fiberglass Shingle	____/____/____	_____	_____	<input type="checkbox"/>
<input type="checkbox"/> 2. Concrete/Clay Tile	____/____/____	_____	_____	<input type="checkbox"/>
<input type="checkbox"/> 3. Metal	____/____/____	_____	_____	<input type="checkbox"/>
<input type="checkbox"/> 4. Built Up	____/____/____	_____	_____	<input type="checkbox"/>
<input type="checkbox"/> 5. Membrane	____/____/____	_____	_____	<input type="checkbox"/>
<input checked="" type="checkbox"/> 6. Other Concrete/TPO	5/19/2010	_____	_____	<input type="checkbox"/>

- ☒ D. Reinforced Concrete Roof Deck.
☐ E. Other: _____
☐ F. Unknown or unidentified.
☐ G. No attic access.

ROOF - CONCRETE WITH TPO COVERING
