# Uniform Mitigation Verification Inspection Form

Inspection Date: FEBRUARY 1, 2025		
<b>Owner Information</b>		
Owner Name: MIDDLEBROOK PINES CONDOS CASE#: 20250201-WMIR-61		Contact Person: KEITH KIEBZAK
Address: 5364, 5366, 5368, 5370 BAMBOO CT - BLDG 61		Home Phone:
City: ORLANDO	Zip: 32811	Work Phone: 407-482-2622
County: ORANGE	FL	Cell Phone:
Insurance Company:		Policy #:
Year of Home: 1986	# of Stories: 2	Email: KLMGMTGROUP@AOL.COM

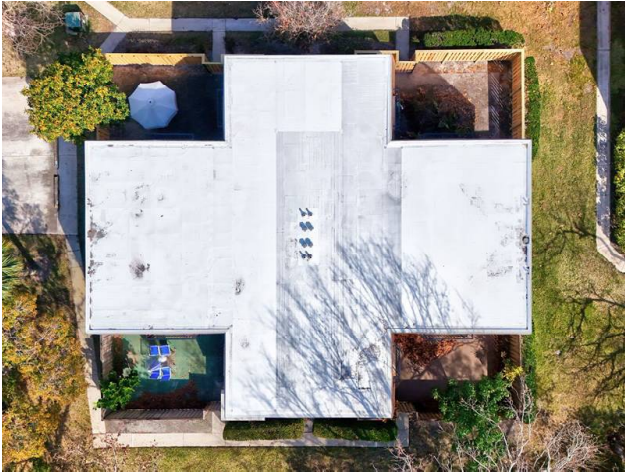
2.1 Roof Covering Type:	Permit Application Date	FBC or MDC Product Approval #	Year of Original Installation or Replacement	No Information Provided for Compliance
<input type="checkbox"/> 1. Asphalt/Fiberglass Shingle	____/____/____	_____	_____	<input type="checkbox"/>
<input type="checkbox"/> 2. Concrete/Clay Tile	____/____/____	_____	_____	<input type="checkbox"/>
<input type="checkbox"/> 3. Metal	____/____/____	_____	_____	<input type="checkbox"/>
<input type="checkbox"/> 4. Built Up	____/____/____	_____	_____	<input type="checkbox"/>
<input type="checkbox"/> 5. Membrane	____/____/____	_____	_____	<input type="checkbox"/>
<input checked="" type="checkbox"/> 6. Other Concrete/TPO	6/9/2010	_____	_____	<input type="checkbox"/>

- ☒ D. Reinforced Concrete Roof Deck.  
☐ E. Other: \_\_\_\_\_  
☐ F. Unknown or unidentified.  
☐ G. No attic access.

ROOF - CONCRETE WITH TPO COVERING
