Uniform Mitigation Verification Inspection Form

Inspection Date: FEBRUARY 1, 2025		
Owner Information		
Owner Name: MIDDLEBROOK PINES CONDOS CASE#: 20250201-WMIR-83		Contact Person: KEITH KIEBZAK
Address: 5251, 5253, 5255, 5257 CYPRESS CT - BLDG 83		Home Phone:
City: ORLANDO	Zip: 32811	Work Phone: 407-482-2622
County: ORANGE	FL	Cell Phone:
Insurance Company:		Policy #:
Year of Home: 1986	# of Stories: 2	Email: KLMGMTGROUP@AOL.COM

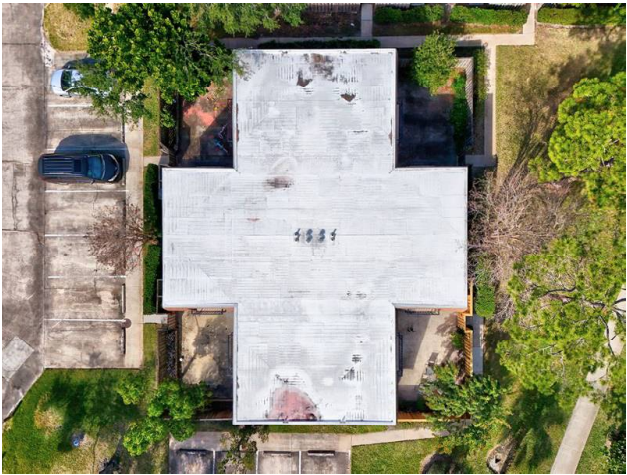
2.1 Roof Covering Type:	Permit Application Date	FBC or MDC Product Approval #	Year of Original Installation or Replacement	No Information Provided for Compliance
<input type="checkbox"/> 1. Asphalt/Fiberglass Shingle	____/____/____	_____	_____	<input type="checkbox"/>
<input type="checkbox"/> 2. Concrete/Clay Tile	____/____/____	_____	_____	<input type="checkbox"/>
<input type="checkbox"/> 3. Metal	____/____/____	_____	_____	<input type="checkbox"/>
<input type="checkbox"/> 4. Built Up	____/____/____	_____	_____	<input type="checkbox"/>
<input type="checkbox"/> 5. Membrane	____/____/____	_____	_____	<input type="checkbox"/>
<input checked="" type="checkbox"/> 6. Other Concrete/TPO	6/16/2011	_____	_____	<input type="checkbox"/>

- ☒ D. Reinforced Concrete Roof Deck.
☐ E. Other: _____
☐ F. Unknown or unidentified.
☐ G. No attic access.

- ☒ E. Structural Anchor bolts structurally connected or reinforced concrete roof.
☐ F. Other: _____
☐ G. Unknown or unidentified
☐ H. No attic access

ROOF - CONCRETE WITH TPO COVERING
