# Uniform Mitigation Verification Inspection Form

Inspection Date: FEBRUARY 1, 2025		
<b>Owner Information</b>		
Owner Name: MIDDLEBROOK PINES CONDOS CASE#: 20250201-WMIR-87		Contact Person: KEITH KIEBZAK
Address: 5255 CYPRESS CT - CLUBHOUSE		Home Phone:
City: ORLANDO	Zip: 32811	Work Phone: 407-482-2622
County: ORANGE	FL	Cell Phone:
Insurance Company:		Policy #:
Year of Home: 1985	# of Stories: 1	Email: KLMGMTGROUP@AOL.COM

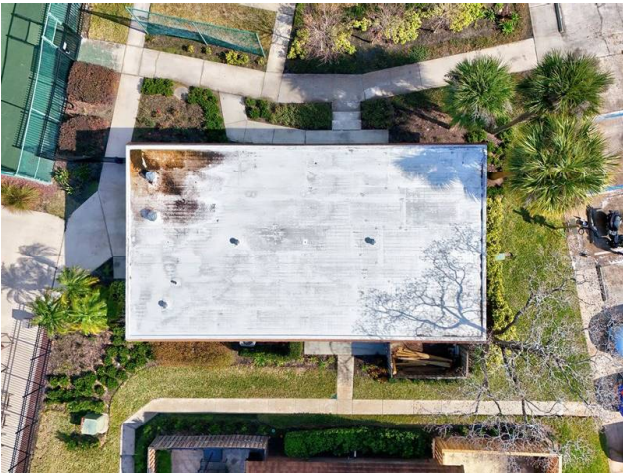
ROOF

2.1 Roof Covering Type:	Permit Application Date	FBC or MDC Product Approval #	Year of Original Installation or Replacement	No Information Provided for Compliance
<input type="checkbox"/> 1. Asphalt/Fiberglass Shingle	____/____/____	_____	_____	<input type="checkbox"/>
<input type="checkbox"/> 2. Concrete/Clay Tile	____/____/____	_____	_____	<input type="checkbox"/>
<input type="checkbox"/> 3. Metal	____/____/____	_____	_____	<input type="checkbox"/>
<input type="checkbox"/> 4. Built Up	____/____/____	_____	_____	<input type="checkbox"/>
<input type="checkbox"/> 5. Membrane	____/____/____	_____	_____	<input type="checkbox"/>
<input checked="" type="checkbox"/> 6. Other Concrete/TPO	____/____/____	_____	AUG 2011	<input type="checkbox"/>

- ☒ D. Reinforced Concrete Roof Deck.  
☐ E. Other: \_\_\_\_\_  
☐ F. Unknown or unidentified.  
☐ G. No attic access.

- ☐ A. Hip Roof      Hip roof with no other roof shapes greater than 10% of the total roof system perimeter.  
Total length of non-hip features: \_\_\_\_\_ feet; Total roof system perimeter: \_\_\_\_\_ feet
- ☒ B. Flat Roof      Roof on a building with 5 or more units where at least 90% of the main roof area has a roof slope of less than 2:12. Roof area with slope less than 2:12 \_\_\_\_\_ sq ft; Total roof area \_\_\_\_\_ sq ft
- ☐ C. Other Roof      Any roof that does not qualify as either (A) or (B) above.

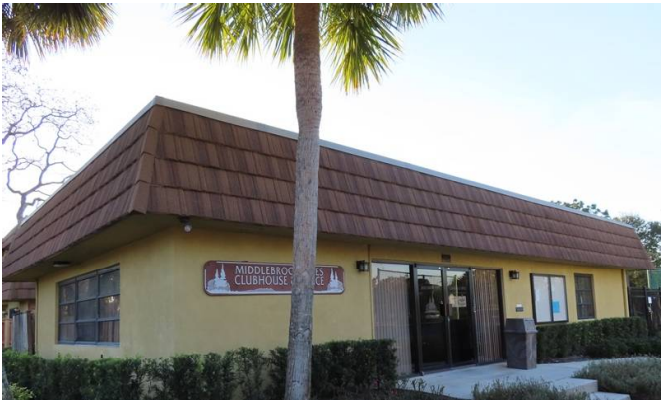
MANSARD WALLS REPLACED 2018
